Memorandum

Re: Deviation from Kalitta Charters Audit Plan Cycle.

INTERNAL EVALUATION PROGRAM

Kalitta Charters - 2020 IEP Report

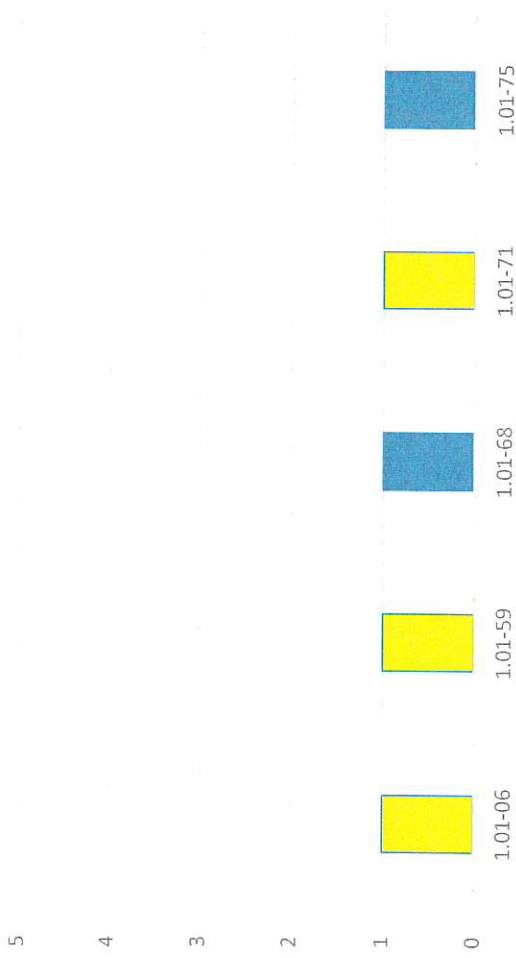
2020 1st Half - Finding/Concerns

1.01-06 – Aircraft List not up to date.

1.01-59 - The Company has not designated a manager who is responsible for the day-to-day management of the SMS system on behalf of the Accountable Executive.

1.01-71 - The Informational bulletin for the Emergency Response Manual has expired.
